Country Club Sewer Maintenance District Final Facilities Assessment Report

December 19, 2012

Imperial County Department of Public Works
155 South 11th Street
El Centro, CA 92243
William S. Brunet PE, Director

Bureau Veritas North America, Inc.
10620 Trenea Street, Suite 200
San Diego, CA 92131
Phone: 858.451.6100 Fax: 858.451.2846
www.us.bureauveritas.com

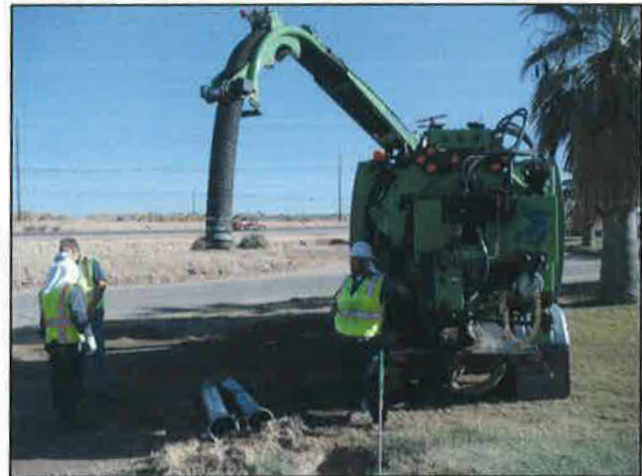
The gravity sewage collection system serving CCSMD was found to be in poor condition due a lack of regular maintenance and large amounts of debris found in the system. Most of the system had to be pumped or cleaned out before being inspected. The pipeline segments that were cleaned and inspected were in generally in good condition with the typical minor issues such as cracked pipes, root intrusions, and offset pipe joints. The original sewer pipelines were installed with slopes and sags that are too flat to be self-cleaning; it is not economical to completely remedy this issue and needs to be addressed through a long-term maintenance program. The sewer system also has inherent problems with maintenance access, as most of the manholes are located in the front and back yards of residences. A preliminary estimate of the capital repairs required for the collection system is \$450,000, including contingencies.

Vector truck cleaning operations.

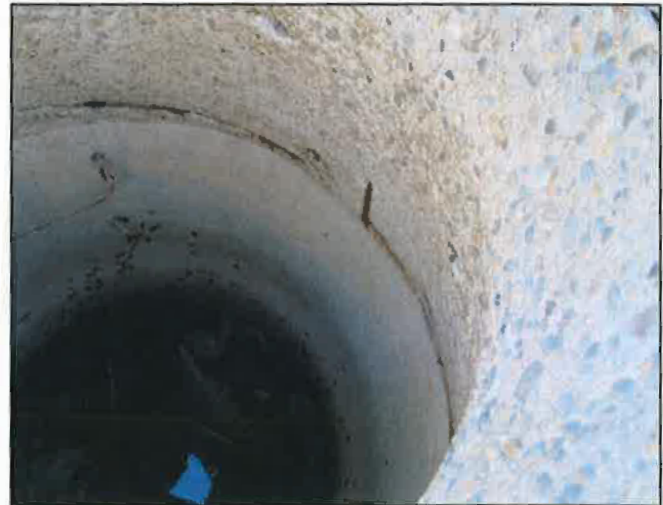
24 of the 34 total manholes within the CCSMD system were inspected and were found to be in fair to very poor condition, depending on location. The remaining manholes were not found, buried, or otherwise inaccessible when the inspections were performed. The lower, base portions of most manholes were found to be in good condition, with the upper portions suffering from concrete corrosion, damaged grade rings, poorly fitted frames and covers, and obstructions blocking access to the manhole opening. Most of the manholes had concentric cones and steel rungs, features no longer considered acceptable for safety reasons. A total of \$460,000 in capital improvements is recommended for the CCSMD manholes, including contingencies.

Manhole 5 showing corrosion.

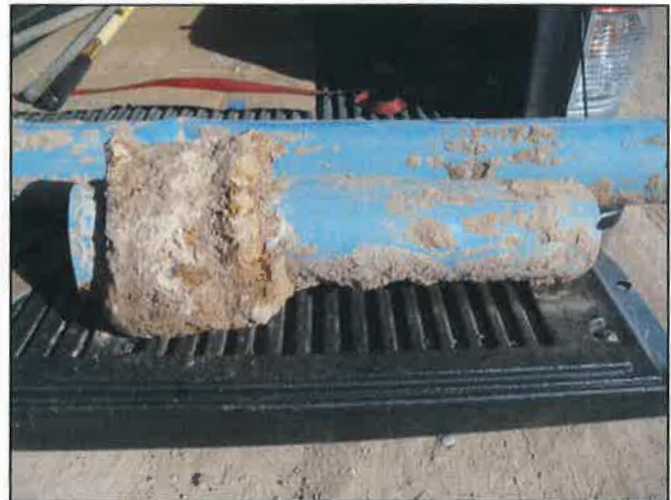
The sewer force main from the pump station was evaluated and found to be undersized from a hydraulic perspective, not allowing the pumps to function in their optimum operating range. The existing force main has also ruptured at least three times in the past several years, most likely due to the marginal strength rating of the original pipe, poor quality control during the initial construction, heat degradation of the pipe material, and pressure spikes from the newer, more powerful pumps. A preliminary estimate of \$740,000 in improvements, including contingencies, are recommended for the sewer force main, the bulk of which is replacement of the existing four-inch force main with a six-inch pipeline.

Existing 4-inch force main pipe removed from the trench.

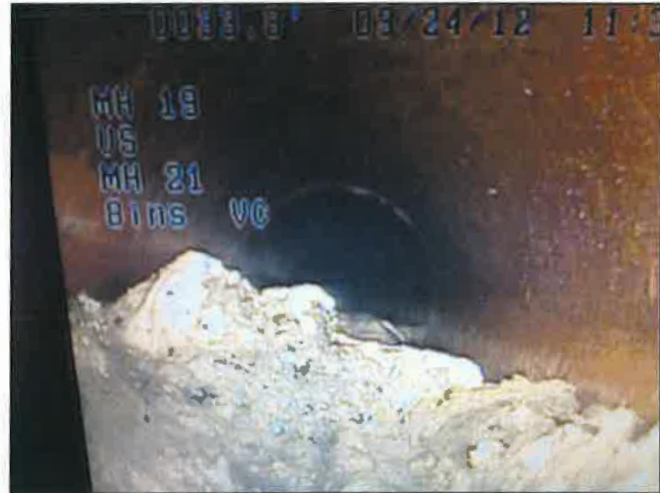
Image taken directly from CCTV camera shows an 8-inch pipeline between MH 19 and 21 that is 25%+ full of silt and debris.

When the actual inspection effort began on September 24, it was quickly apparent that the pipelines were suffering from a lack of regular maintenance. It was not possible to get the camera into many of the sewer mains due to extensive accumulations of silt, dirt, grease, and other debris. Nearly all of the sewer mains were found to be as much as 90% full of silt and debris; others had blockages from large clumps of grease and tree roots; and others were surcharged with effluent, preventing inspection. Imperial County Department of Public Works (ICDPW) staff arranged to pump out the surcharged mains between MH 1 and MH 5 for inspection, revealing that they were also mostly blocked by debris. Attempted flushing of the lines with a water truck only served to move the debris to the next section of pipe. Following this effort a solid clump of grease and debris was observed in MH 1 that was approximately 6 inches by 6 inches by 24 inches and is illustrative of the debris issues with the system.

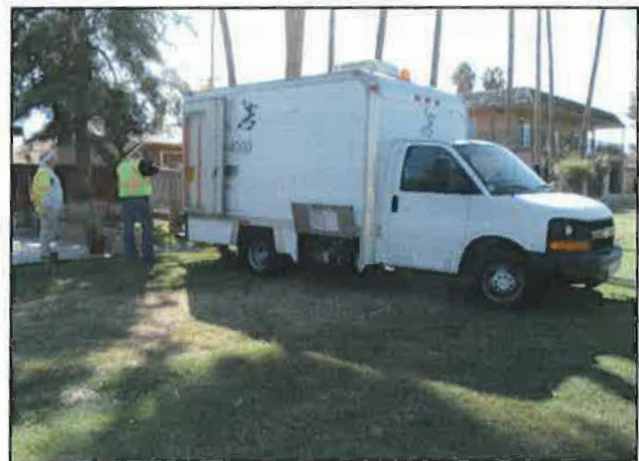
Video inspection operations at MH 26. Note the location of the manhole and sewer line at the rear of the van within private backyards; this is one of the more accessible locations.

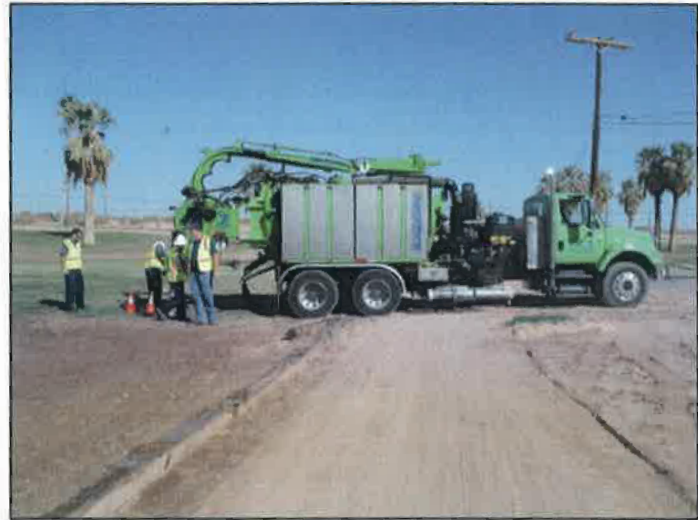
Vactor truck cleaning operations at newly located MH 7 within the golf course. Note the size of the equipment required to efficiently maintain the system.

The pipeline sections that cross the golf course were found to be nearly full of silt that prevented access for inspections. The heavy irrigation of the golf course can carry fine material from the soil into the sewer pipeline through small cracks or open joints, eventually filling the pipe with silt. Replacing the entire gravity collection system at the proper minimum slope is not economically feasible, and would in turn require replacement of the pump station and likely the force main. Instead, CCSMD should institute a program of regular annual maintenance to address these issues, as well as a capital repair program to address the existing operational issues that have been identified.

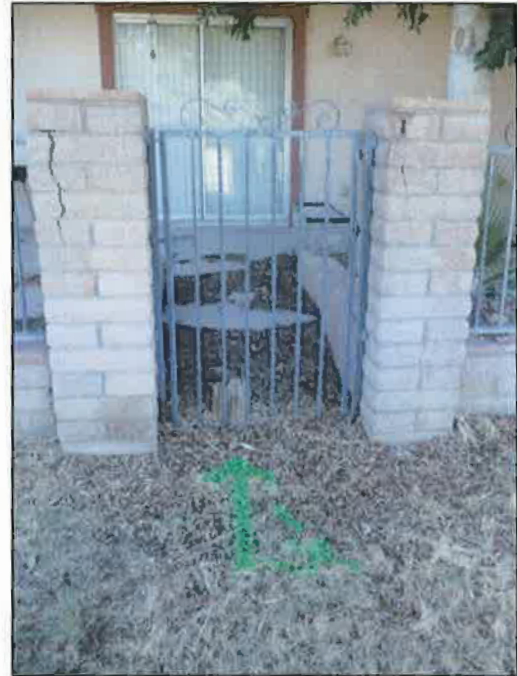
Location of MH 25 within a private patio, as located by the video camera with a tracking device.

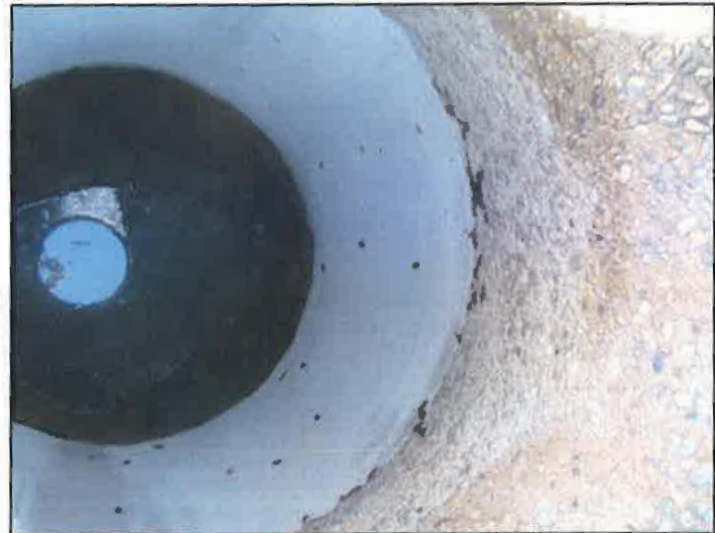
As with the sewer mains, the manholes are also suffering from lack of regular maintenance. The interior surfaces of many of the manholes were originally lined with a bituminous coating. This coating has now largely flaked and peeled off to such a point that it is ineffective, exposing the concrete rings and cone to corrosion from hydrogen sulfide sewer gases. Many cases of concrete corrosion were observed in the field due to the trapped gas, high temperatures, and confined atmosphere. Many of the manhole troughs and shelves were deteriorating in a similar manner.

Typical concrete corrosion found within the cone of many of the CCSMD manholes. The concrete cone on the right should be smooth with no exposed aggregate, similar to the section below.

Rebar was observed in broken grade rings during the manhole inspections, indicating that the manhole rings and cones are precast reinforced concrete. As no exposed rebar or evidence of rebar corrosion was observed inside the manholes it is probable that all manholes inspected can be rehabilitated in place, as opposed to being completely replaced. Bureau Veritas recommends replacing and coating all manhole shelves, troughs, and rings internally with a corrosion resistant coating such as epoxy.

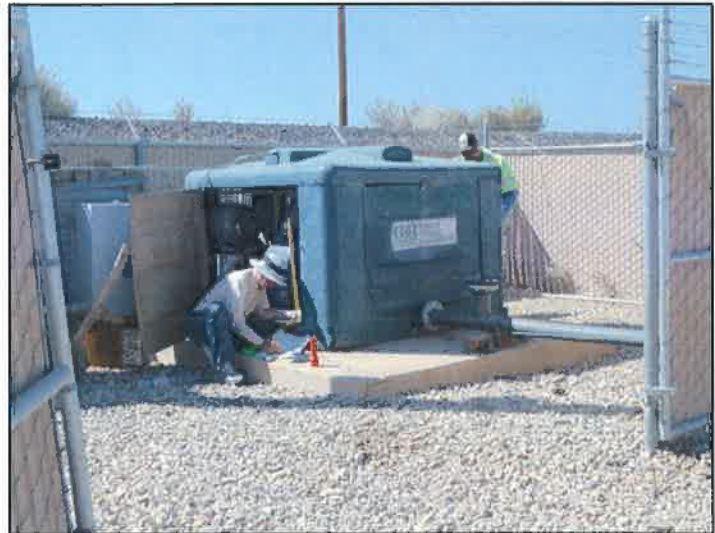
Performance of pump station data collection and operational tests. The pump station was last upgraded in 2004 and was found to be in acceptable condition, with only minor modifications required.

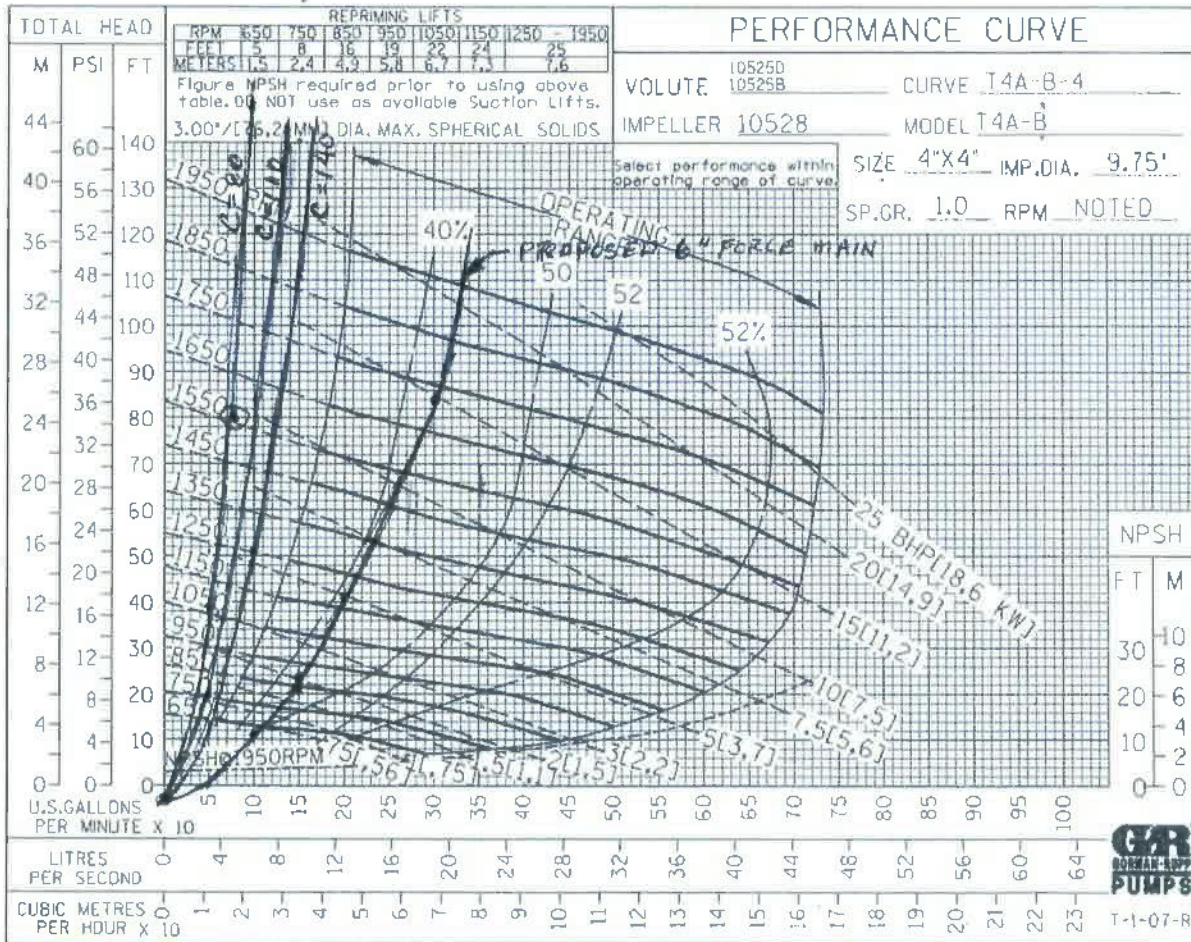
Figure 1: Gorman-Rupp T4A-B-4 Pump Performance Curve. Note the circled point on left side, which represents the operating point for the existing pumps and is outside the manufacturer's preferred operating range. Replacement of the force main with a six-inch pipeline would bring the curve back into the optimum operating range as indicated by the hand drawn curve.

The pumps are operating to the left side of the pump curve (Figure 1), in an area that is outside the operating range recommended by the manufacturer. This occurrence usually results in discharge cavitation, which can adversely affect the pump impeller and its performance. Cavitation issues can be corrected by increasing the flow rate, which could be accomplished by increasing the force main size, thereby lowering the friction head loss in the pipeline.

ICDPW's operator indicated that Pump #2 functions better than Pump #1. The Gorman-Rupp factory engineers strongly recommend that the pump impellers and wear plates be adjusted by factory technicians at least once a year to assure good performance.

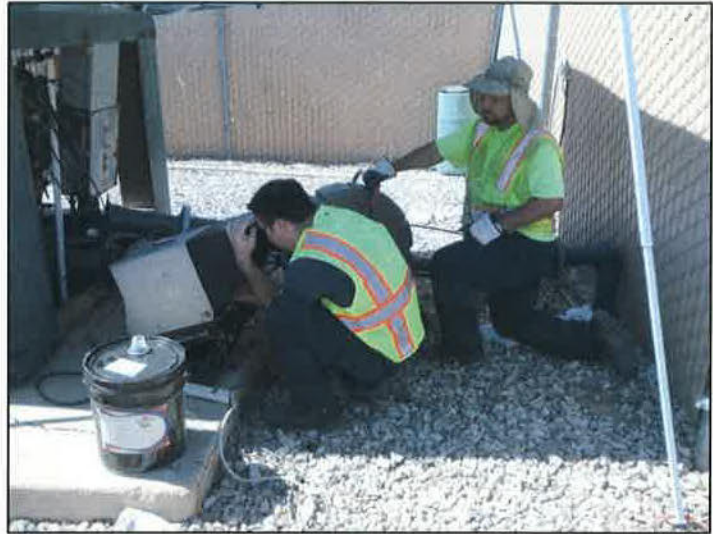
Initial video inspection of the force main with a push camera. Pump station is on the left and force main is on the right. Note the sharp 90-degree bend in the force main next to the fence.

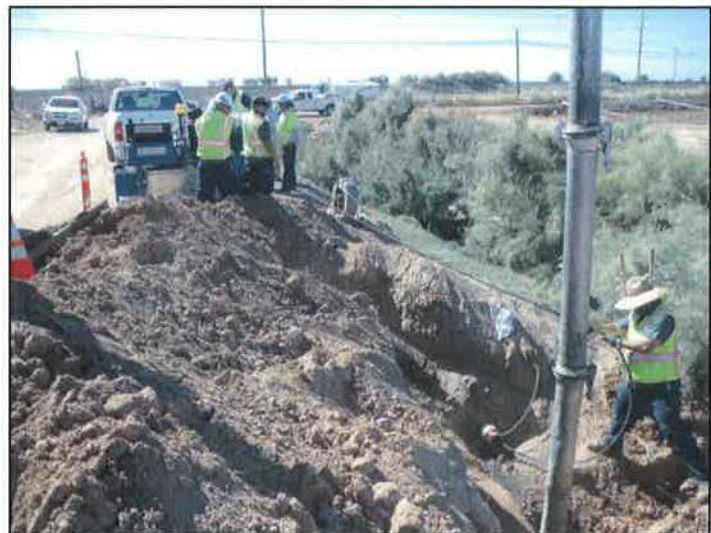
Second video inspection of the force main along Barbara Worth Drain, pump station is in the left background. The end of the pipeline can be seen in the trench, one line in the pipe is the video cable, the other is the jetter line used to pull the camera into the pipe.

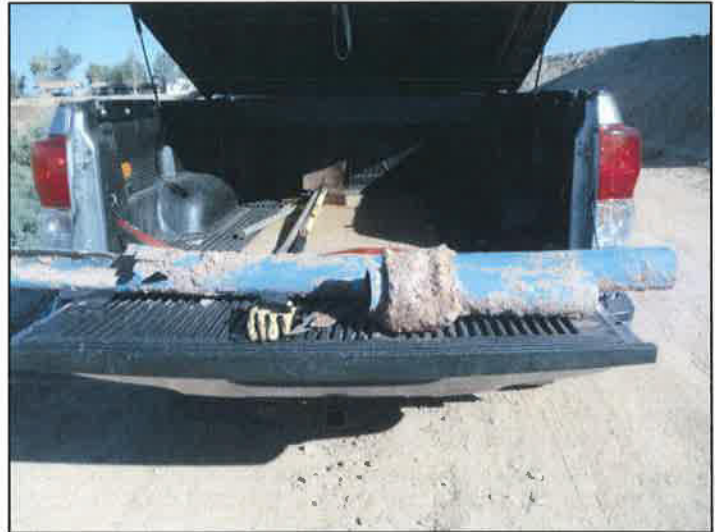
be even more of a concern on a force main which experiences pressure spikes due to pump operations, as opposed to a gravity-fed water supply main which would normally see consistent pressure levels. PVC pipe is also sensitive to ultraviolet (UV) radiation if installed or stored outdoors for extended periods without protection. Older, above-ground sections of pipe at the pump station had some indications of UV degradation, although it is not known if UV exposure contributed to the cracking or splintering of the force main sections that were inspected. It is more likely that the crack was caused by rough handling of the pipe at the time of installation.

Existing 4-inch force main pipe removed from the trench. Note the splintered section on the left, repair coupling in the middle, and the barely visible chip and crack in the spigot end of the shorter section on the right.

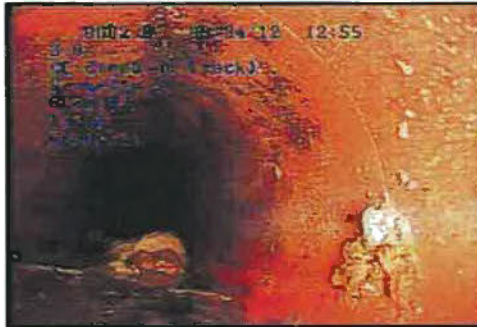
Date: 09/24/2012
 Distance: 2.0 Ft
 Obs: Circular Crack

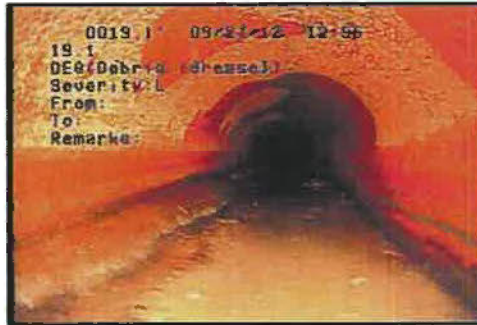
Date: 09/24/2012
 Distance: 10.1 Ft
 Obs: Debris (Grease)

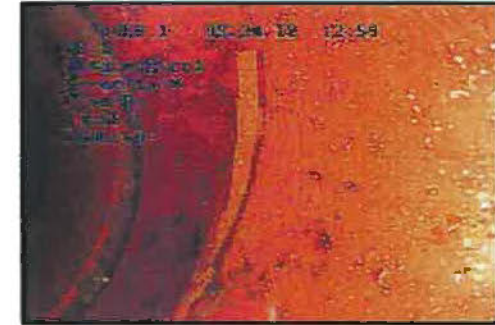
Date: 09/24/2012
 Distance: 68.1 Ft
 Obs: Corrosion of CI

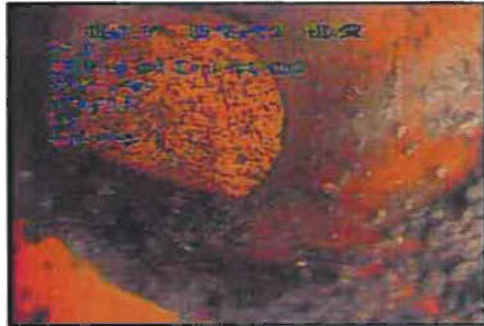
Date: 09/24/2012
 Distance: 47.8 Ft
 Obs: Plugged Connection

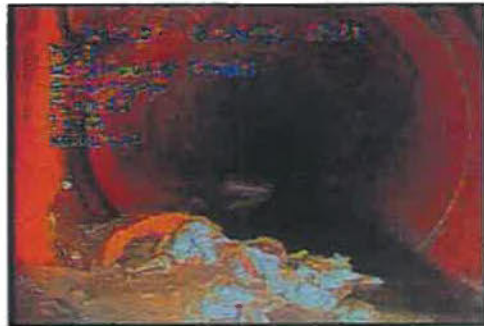
Date: 09/24/2012
 Distance: 74.3 Ft
 Obs: Circular Crack

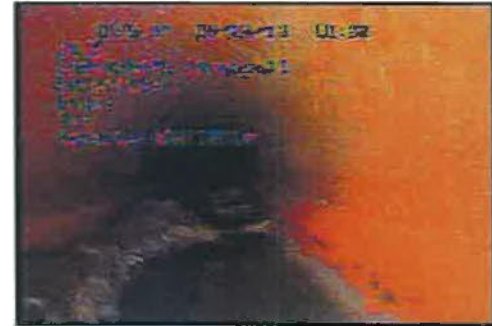
Date: 09/24/2012
 Distance: 53.1 Ft
 Obs: Debris (Grease)

Comments:
 CONTINUIG

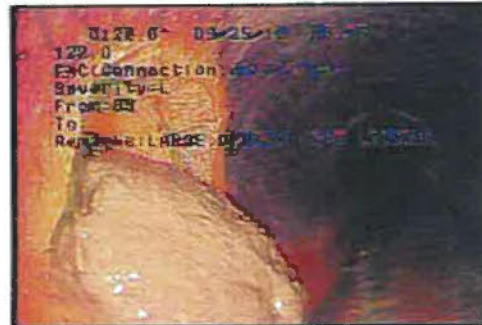
Comments:
 LARGE DEBRIS FROM LATERAL
