Country Club Sewer Maintenance District Final Facilities Assessment Report

December 19, 2012

Imperial County Department of Public Works
155 South 11th Street
El Centro, CA 92243
William S. Brunet PE, Director

Bureau Veritas North America, Inc.
10620 Trenea Street, Suite 200
San Diego, CA 92131
Phone: 858.451.6100 Fax: 858.451.2846
www.us.bureauveritas.com

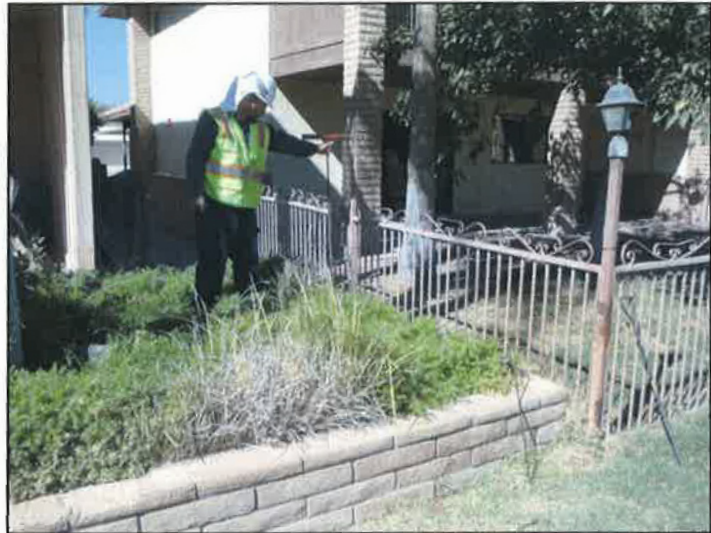
The worker is holding the probe at the center of MH 29, which is in a private backyard underneath the decorative wall on the left and the wrought iron fence on the right.
