Country Club Sewer Maintenance District Final Facilities Assessment Report

December 19, 2012

Imperial County Department of Public Works
155 South 11th Street
El Centro, CA 92243
William S. Brunet PE, Director

Bureau Veritas North America, Inc.
10620 Trenea Street, Suite 200
San Diego, CA 92131
Phone: 858.451.6100 Fax: 858.451.2846
www.us.bureauveritas.com

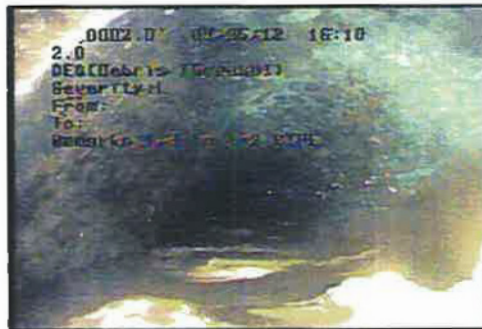
Date: 09/25/2012
Distance: 2.0 Ft
Obs: Debris (Grease)

Comments:
1/3 to 1/2 PIPE

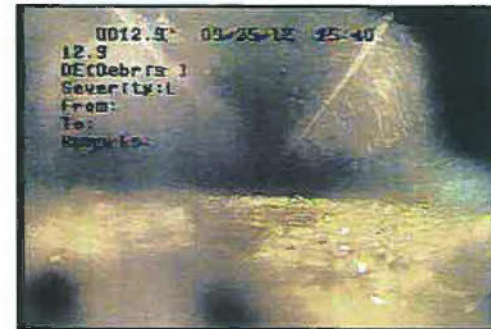
Obs: Debris

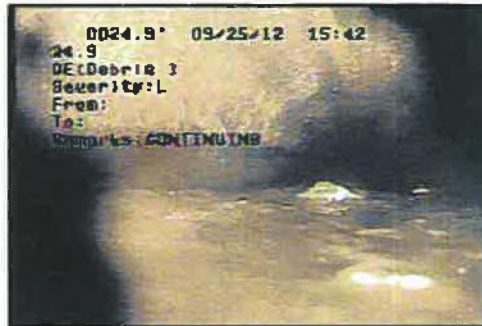
Obs: Debris

Comments:
CONTINUING

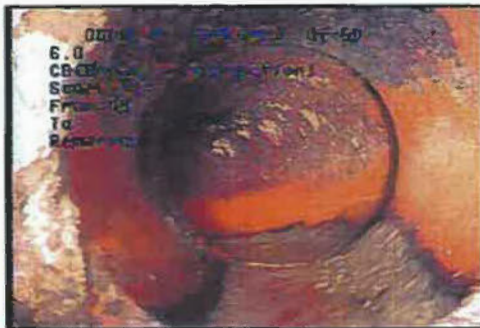
Obs: Break in Connection

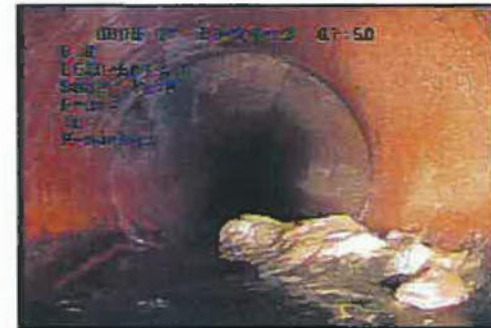
Obs: Debris

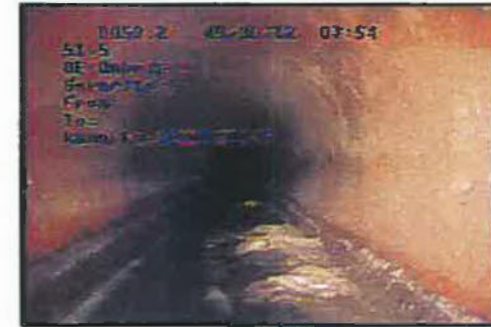
Obs: Debris

Comments:
CONTINUING

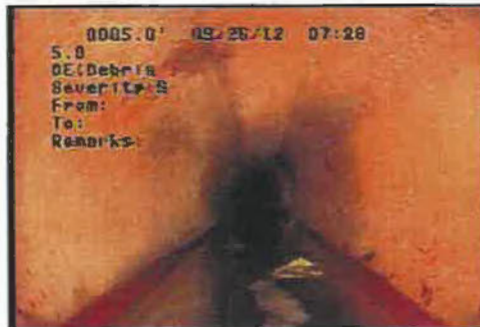
Obs: Debris

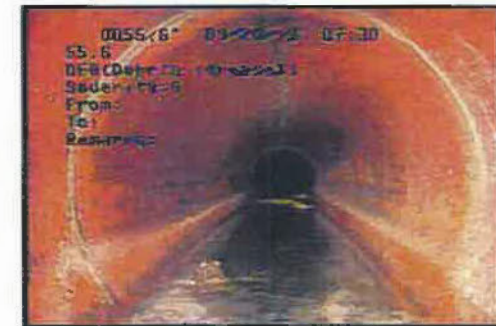
Obs: Debris (Grease)

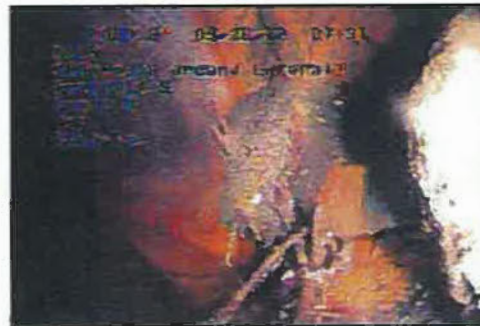
Obs: Roots around Lateral

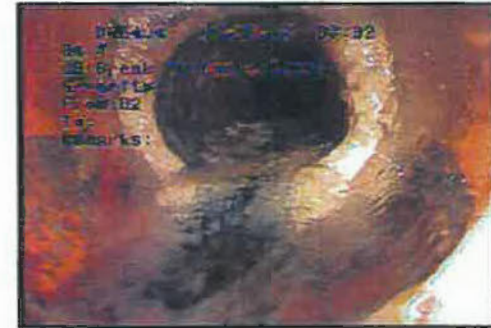
Date: 09/26/2012
 Distance: 84.4 Ft
 Obs: Break in Connection

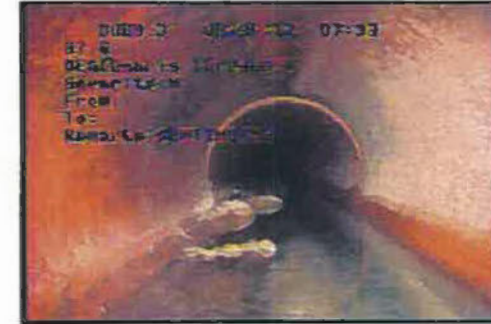
Date: 09/26/2012
 Distance: 87.6 Ft
 Obs: Debris (Grease)

Comments:
 CONTINUING

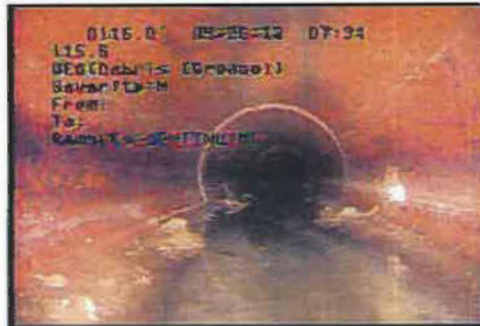
Date: 09/26/2012
 Distance: 115.6 Ft
 Obs: Debris (Grease)

Comments:
 CONTINUING

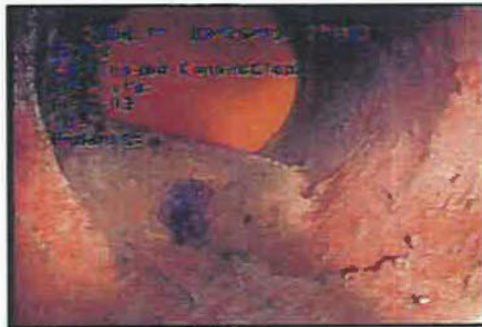
Date: 09/26/2012
Distance: 196.6 Ft
Obs: Plugged Connection

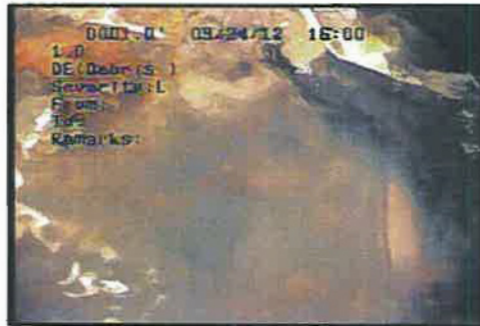
Obs: Debris

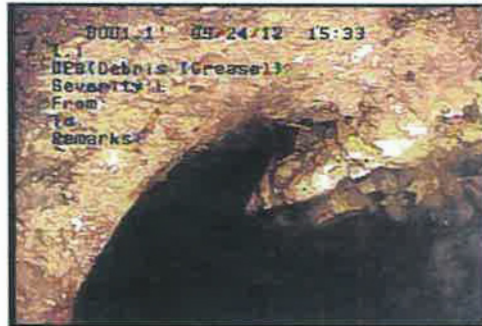
Obs: Debris (Grease)

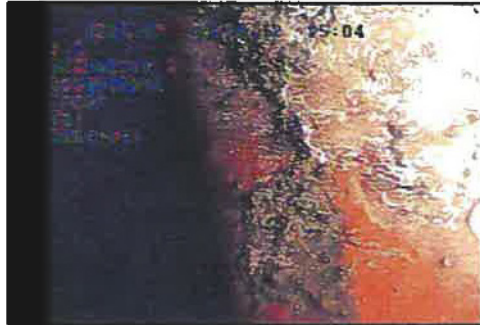
Obs: Debris

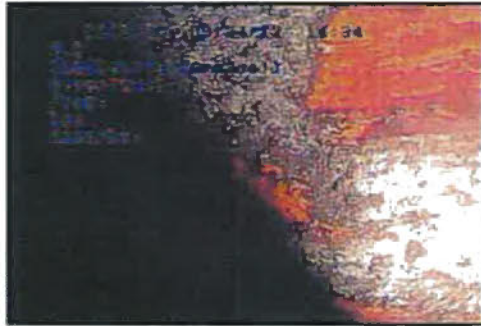
Obs: Debris (Grease)

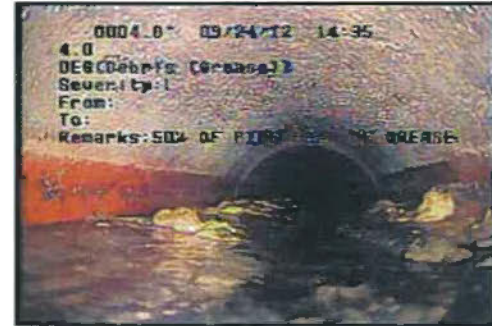
50% OF PIPE FULL OF GREASE

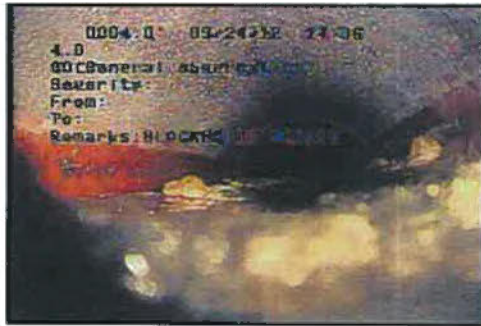
BLOCKED BY GREASE

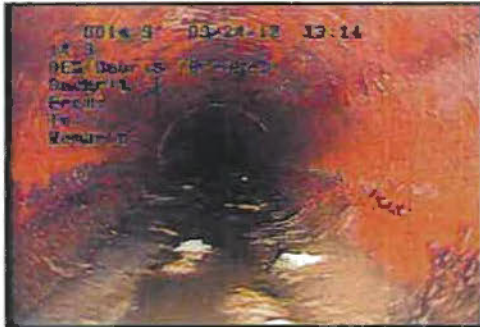
Date: 09/24/2012
 Distance: 14.9 Ft
 Obs: Debris (Grease)

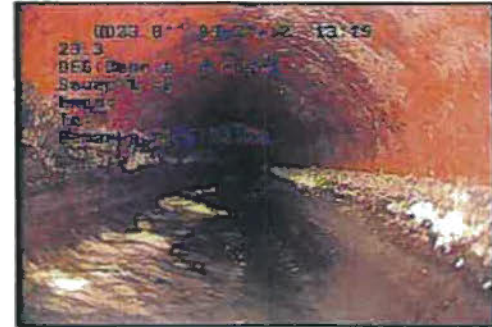
Date: 09/24/2012
 Distance: 23.3 Ft
 Obs: Debris (Grease)

Comments:
CONTINUING

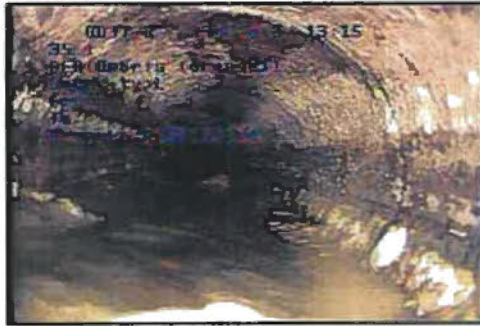
Date: 09/24/2012
 Distance: 35.1 Ft
 Obs: Debris (Grease)

Comments:
CONTINUING

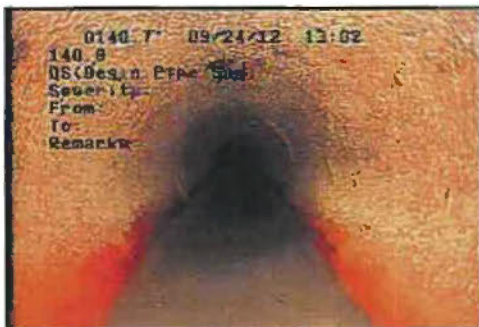
Date: 09/24/2012
 Distance: 140.8 Ft
 Obs: Begin Pipe Sag

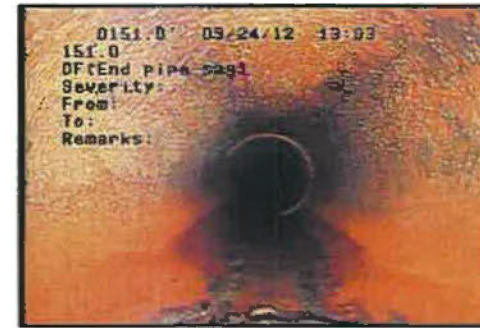
Date: 09/24/2012
 Distance: 151.0 Ft
 Obs: End pipe sag

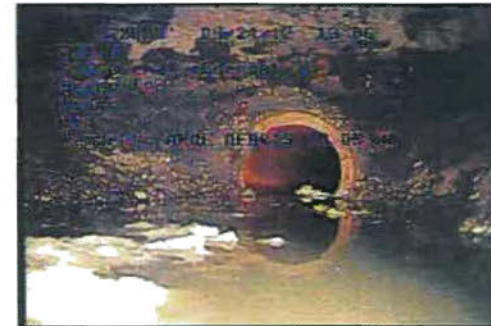
LARGE DEBRIS IN DS MH

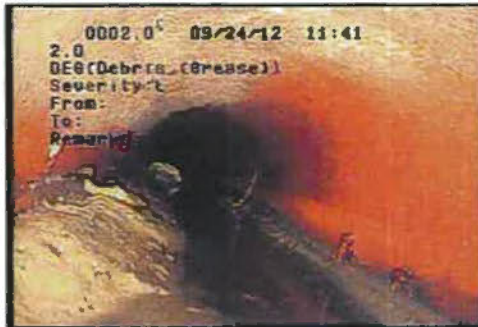
Date: 09/24/2012
 Distance: 2.0 Ft
 Obs: Debris (Grease)

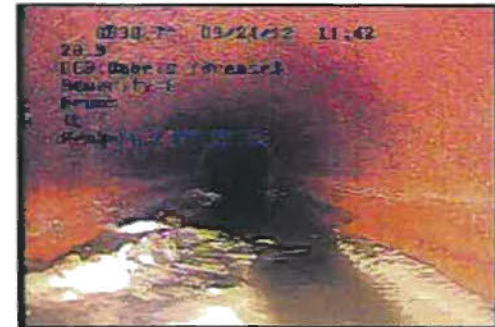
Date: 09/24/2012
 Distance: 28.9 Ft
 Obs: Debris (Grease)

Comments:
CONTINUING

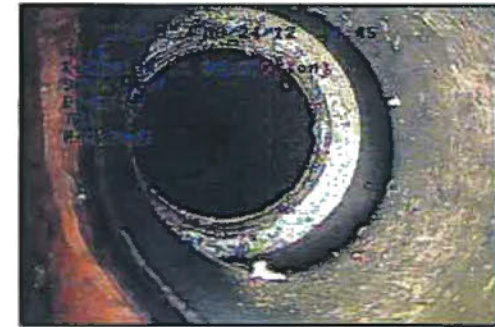
Date: 09/24/2012
 Distance: 78.9 Ft
 Obs: Break in Connection

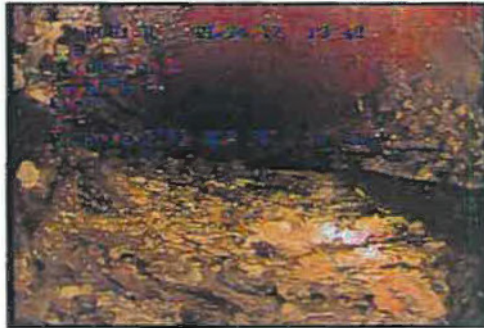
PIPE 80% FULL OF DIRT

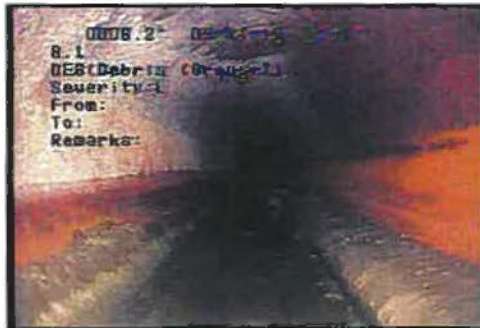
Date: 09/24/2012
 Distance: 8.1 Ft
 Obs: Debris (Grease)

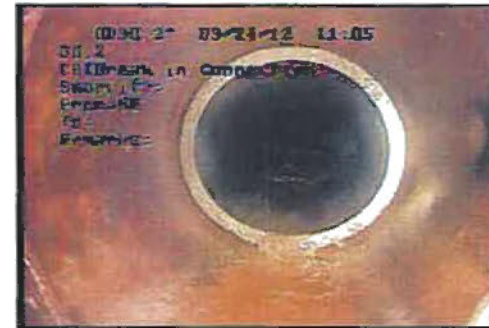
Date: 09/24/2012
 Distance: 30.2 Ft
 Obs: Break in Connection

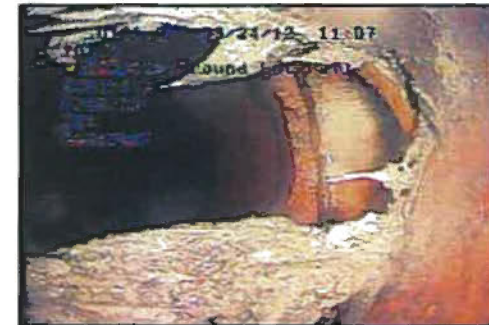
Date: 09/24/2012
 Distance: 101.8 Ft
 Obs: Roots around Lateral

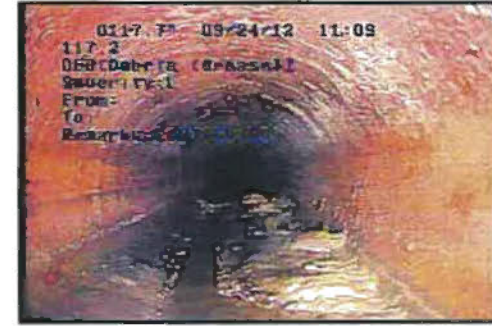
Date: 09/24/2012
 Distance: 117.2 Ft
 Obs: Debris (Grease)

Comments:
 CONTINUING

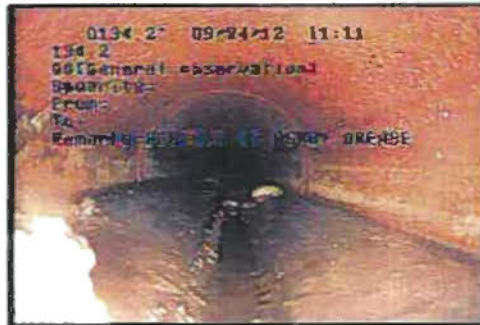
Date: 09/24/2012
 Distance: 134.2 Ft
 Obs: General observation

Comments:
 BLOCKED BY HEAVY
 GREASE

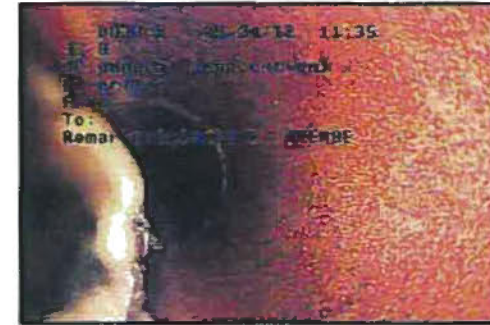
Date: 09/24/2012
Distance: 33.8 Ft
Obs: General observation

Comments:
 BLOCKED BY GREASE

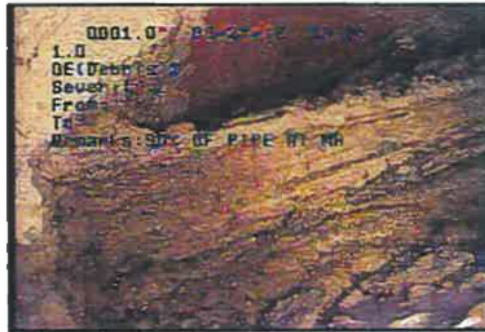
90% OF PIPE AT MH

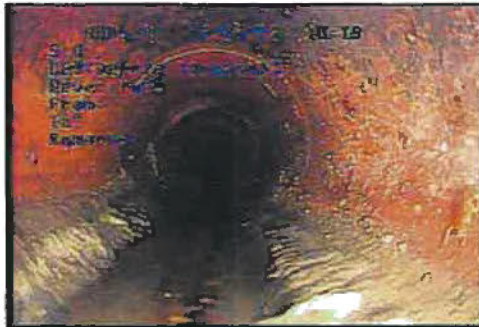
Date: 09/24/2012
 Distance: 5.0 Ft
 Obs: Debris (Grease)

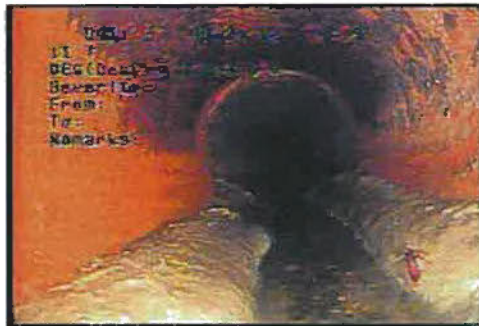
Date: 09/24/2012
 Distance: 11.7 Ft
 Obs: Debris (Grease)

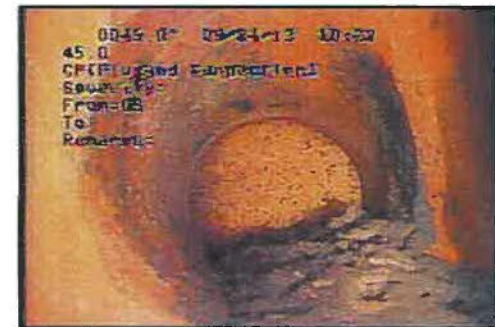
Date: 09/24/2012
 Distance: 45.0 Ft
 Obs: Plugged Connection

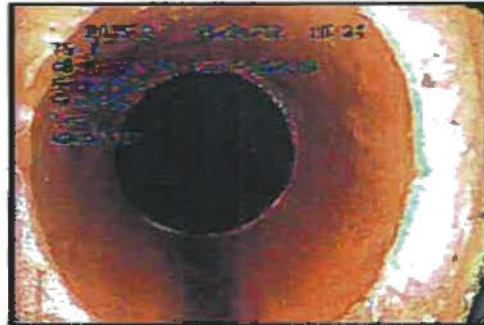
Date: 09/24/2012
 Distance: 75.3 Ft
 Obs: Break in Connection

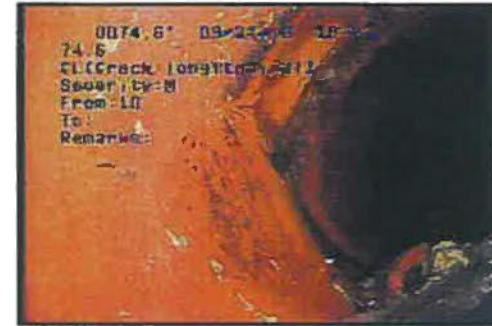
Date: 09/24/2012
 Distance: 74.6 Ft
 Obs: Crack longitudinal

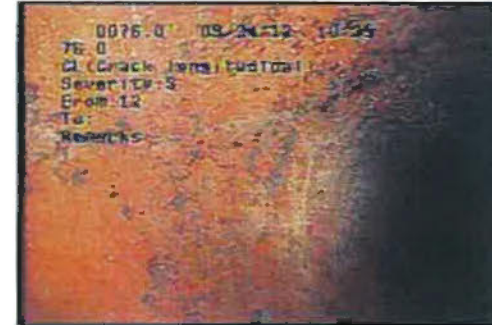
Date: 09/24/2012
 Distance: 76.0 Ft
 Obs: Crack longitudinal

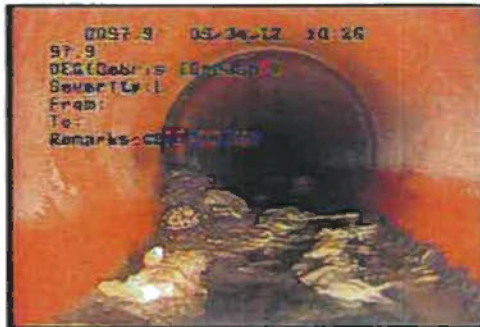
Date: 09/24/2012
 Distance: 97.9 Ft
 Obs: Debris (Grease)

Comments:
 CONTINUING

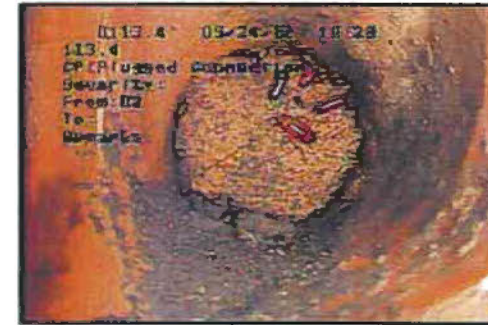
Date: 09/24/2012
 Distance: 113.4 Ft
 Obs: Plugged Connection

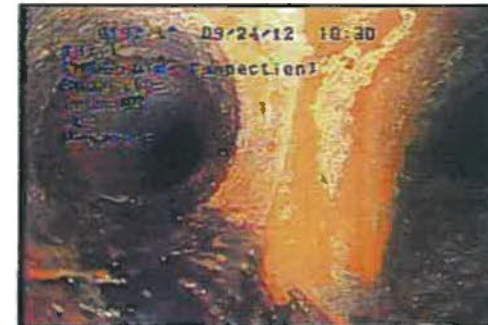
Date: 09/24/2012
 Distance: 197.1 Ft
 Obs: Service Connection

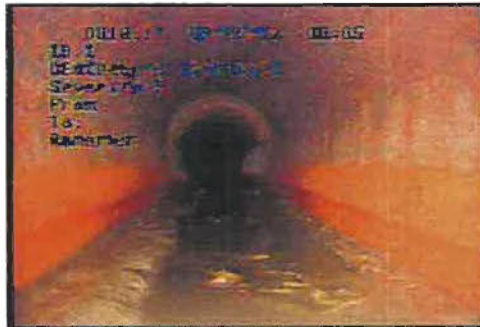
Date: 09/25/2012
Distance: 18.1 Ft
Obs: Debris (Grease)

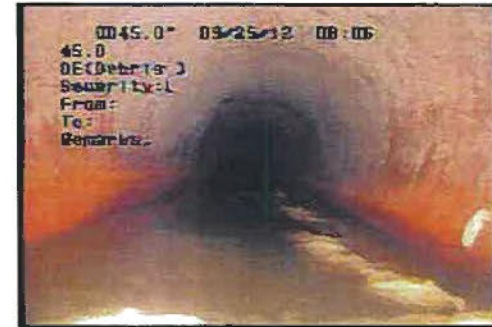
Date: 09/25/2012
Distance: 45.0 Ft
Obs: Debris

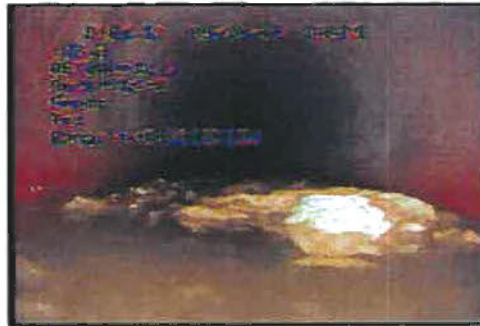
Date: 09/25/2012
Distance: 103.3 Ft
Obs: Debris

Comments:
CONTINUING

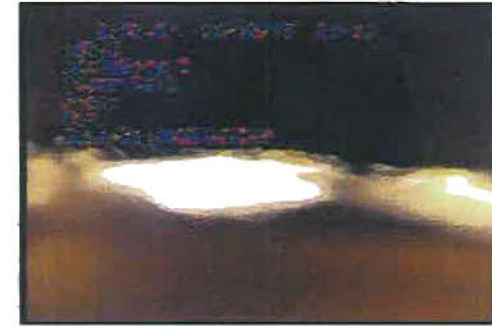
Date: 09/25/2012
Distance: 126.0 Ft
Obs: Debris

Comments:
CONTINUING

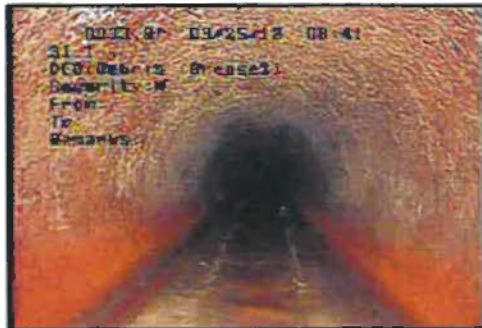
Date: 09/25/2012
 Distance: 31.1 Ft
 Obs: Debris (Grease)

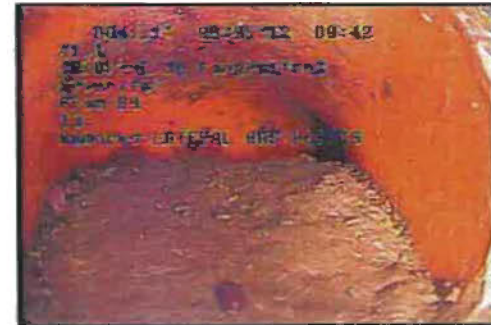
Date: 09/25/2012
 Distance: 41.1 Ft
 Obs: Break in Connection

Comments:
 LATERAL HAS DEBRIS

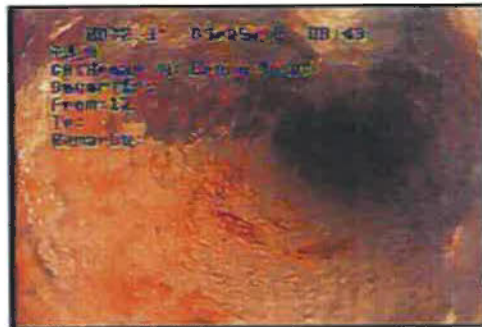
Date: 09/25/2012
 Distance: 72.3 Ft
 Obs: Break in Connection

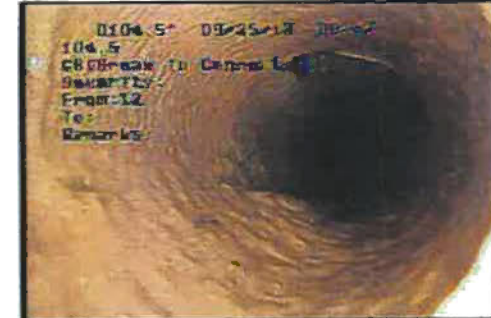
Date: 09/25/2012
 Distance: 104.5 Ft
 Obs: Break in Connection

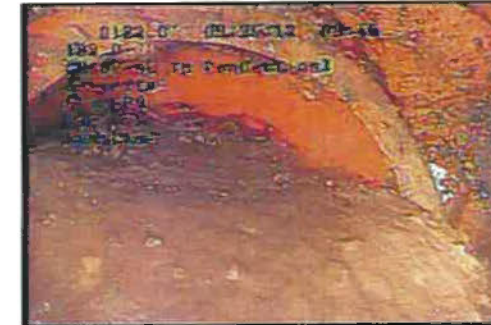
Date: 09/25/2012
 Distance: 122.0 Ft
 Obs: Break in Connection

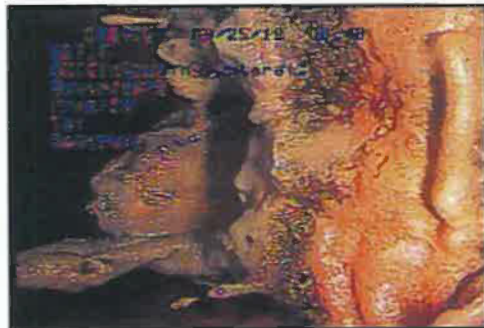
Date: 09/25/2012
 Distance: 187.7 Ft
 Obs: Intruding Lateral

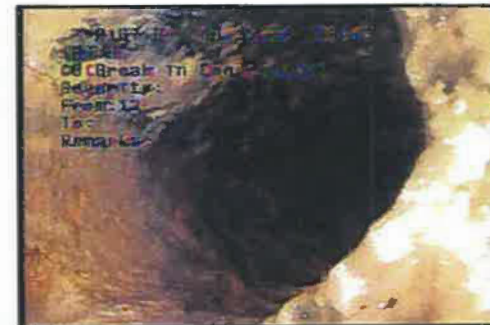
Date: 09/25/2012
 Distance: 187.8 Ft
 Obs: Break in Connection

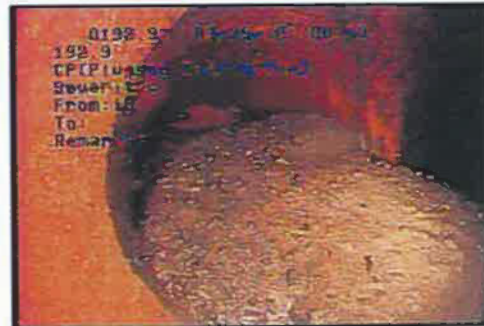
Date: 09/25/2012
 Distance: 192.9 Ft
 Obs: Plugged Connection

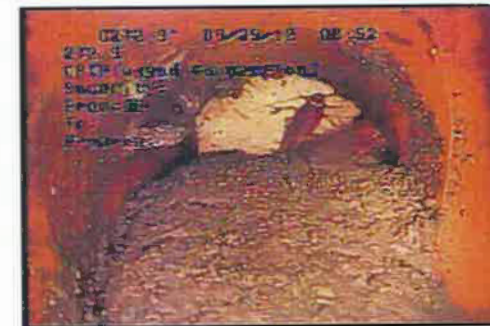
Date: 09/25/2012
 Distance: 272.9 Ft
 Obs: Plugged Connection

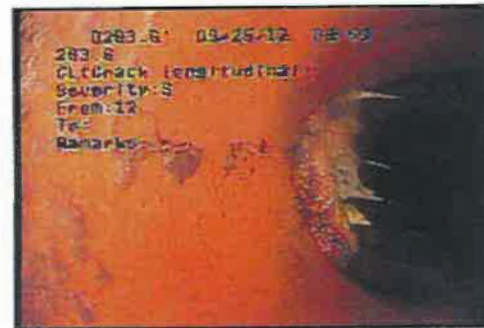
Date: 09/25/2012
 Distance: 283.8 Ft
 Obs: Crack longitudinal

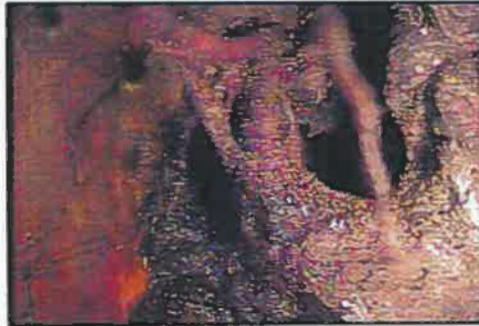
Date: 09/25/2012
Distance: 350.1 Ft
Obs: Roots from lateral

Comments:
LARGE TAP ROOTS

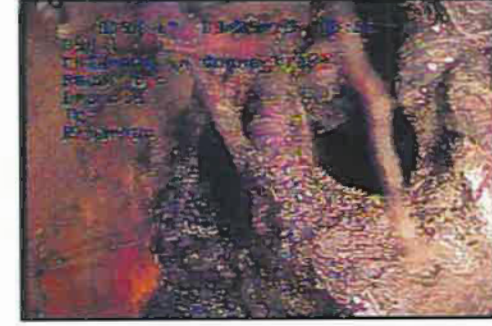
Date: 09/25/2012
Distance: 350.1 Ft
Obs: Break in Connection

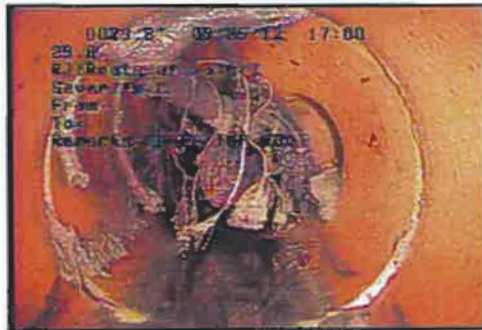
Date: 09/25/2012
Distance: 29.8 Ft
Obs: Roots at joint

Comments:
LARGE TAP ROOT

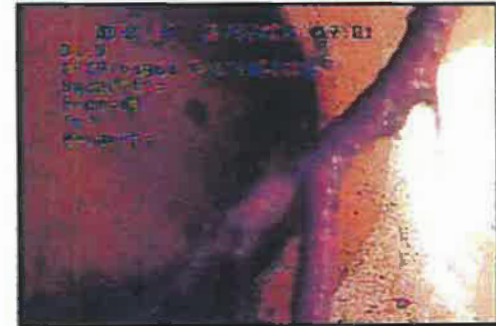
Date: 09/25/2012
Distance: 31.3 Ft
Obs: Plugged Connection

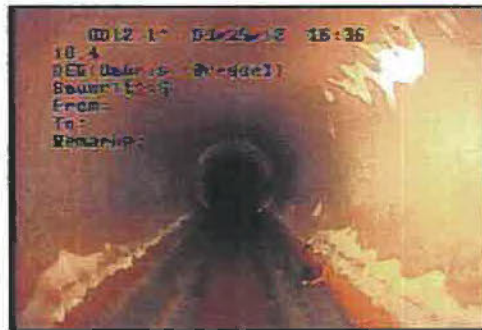
Date: 09/25/2012
 Distance: 10.4 Ft
 Obs: Debris (Grease)

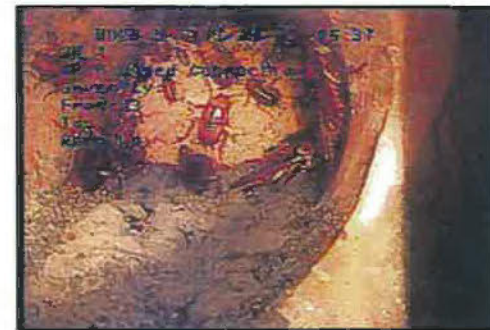
Date: 09/25/2012
 Distance: 20.4 Ft
 Obs: Plugged Connection

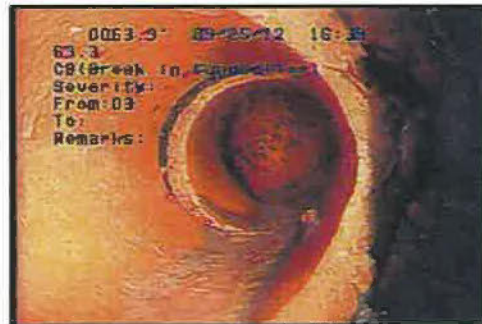
Date: 09/25/2012
 Distance: 63.3 Ft
 Obs: Break in Connection

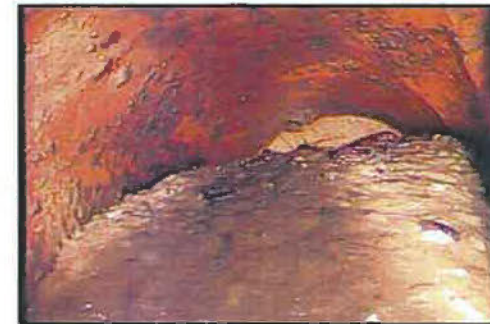
Date: 09/25/2012
 Distance: 92.7 Ft
 Obs: Plugged Connection

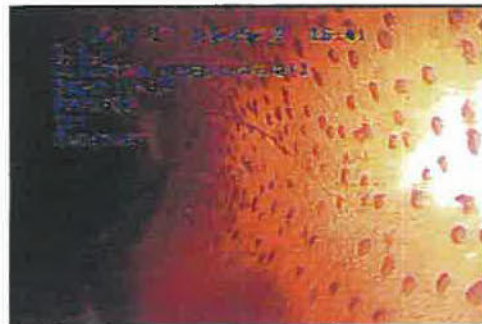
Date: 09/25/2012
 Distance: 111.0 Ft
 Obs: Crack longitudinal

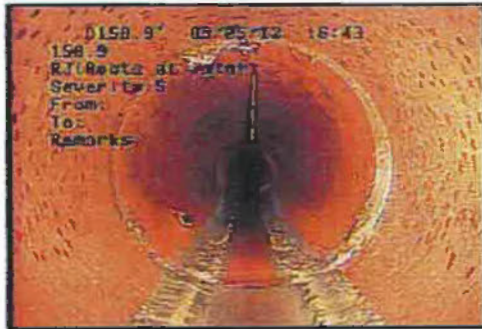
Date: 09/25/2012
 Distance: 158.9 Ft
 Obs: Roots at joint

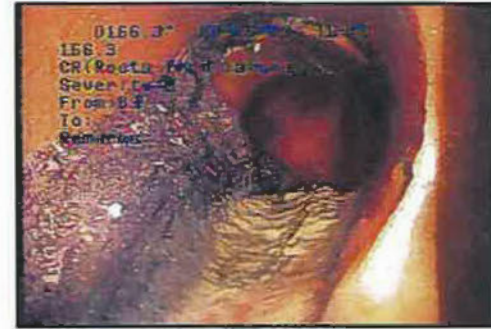
Date: 09/25/2012
 Distance: 166.3 Ft
 Obs: Roots from lateral

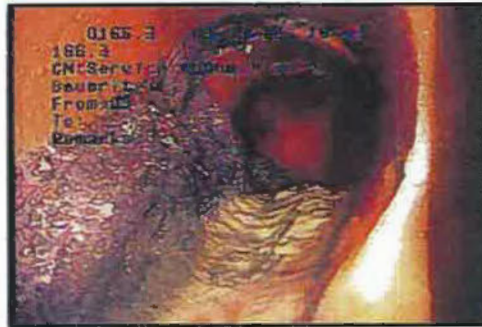
Date: 09/25/2012
 Distance: 166.3 Ft
 Obs: Service Connection

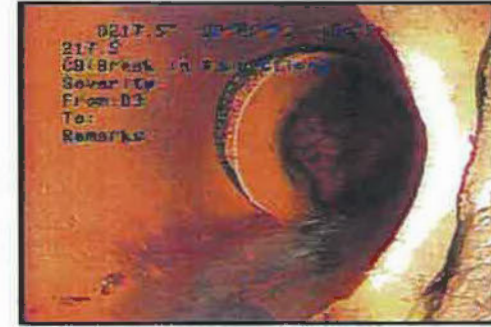
Date: 09/25/2012
 Distance: 217.5 Ft
 Obs: Break in Connection

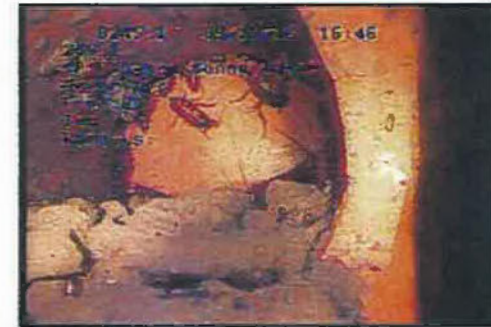
Date: 09/25/2012
 Distance: 245.1 Ft
 Obs: Plugged Connection

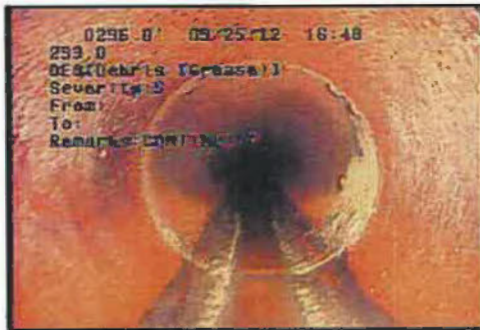
Date: 09/25/2012
 Distance: 293.0 Ft
 Obs: Debris (Grease)

Comments:
 CONTINUING

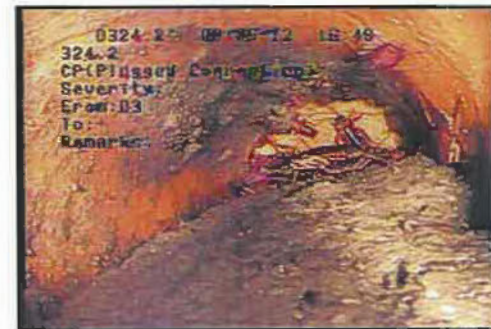
Date: 09/25/2012
 Distance: 324.2 Ft
 Obs: Plugged Connection

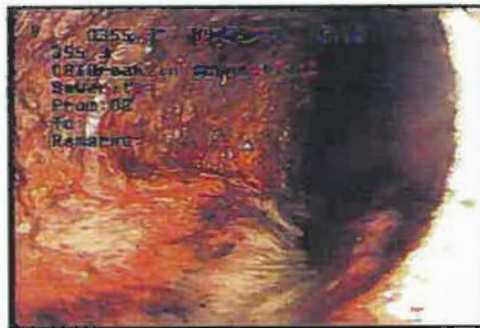
Date: 09/25/2012
 Distance: 355.3 Ft
 Obs: Break in Connection

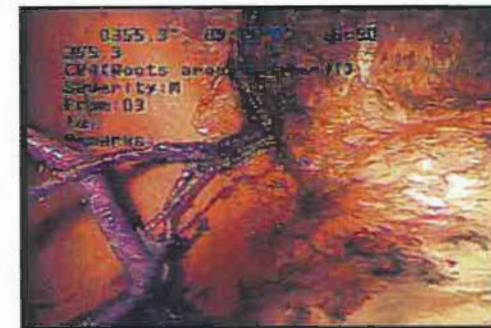
Date: 09/25/2012
 Distance: 355.3 Ft
 Obs: Roots around Lateral

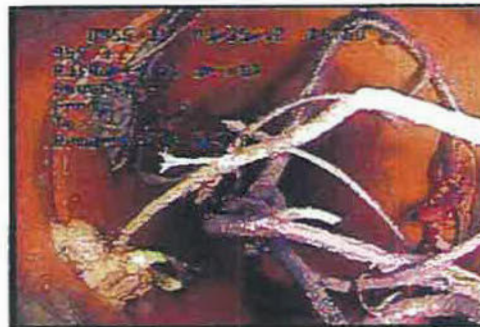
Date: 09/25/2012
 Distance: 355.3 Ft
 Obs: Roots at joint

Comments:
 TAP ROOTS

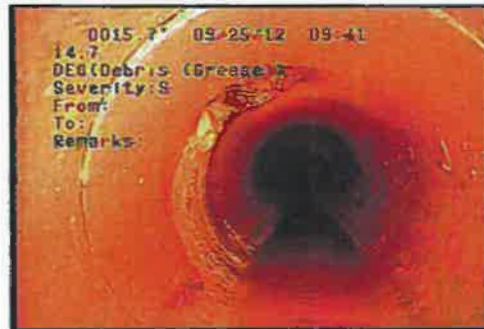
Date: 09/25/2012
 Distance: 14.7 Ft
 Obs: Debris (Grease)

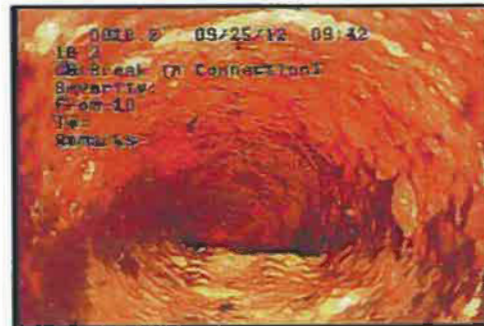
Date: 09/25/2012
 Distance: 18.2 Ft
 Obs: Break in Connection

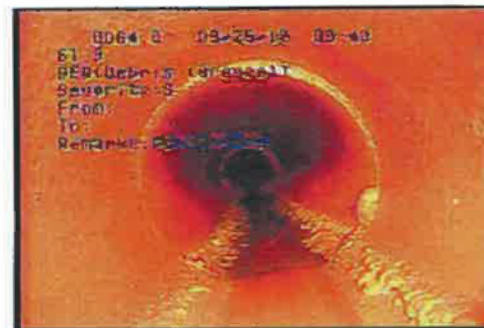
Date: 09/25/2012
 Distance: 61.3 Ft
 Obs: Debris (Grease)

Comments:
 CONTINUING

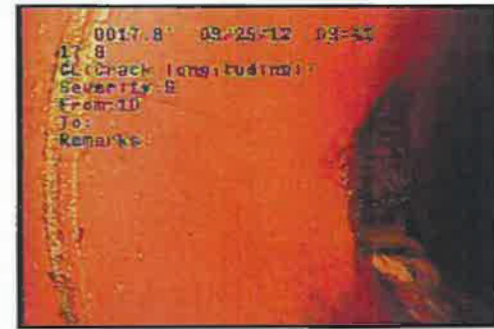
Date: 09/25/2012
 Distance: 17.8 Ft
 Obs: Crack longitudinal

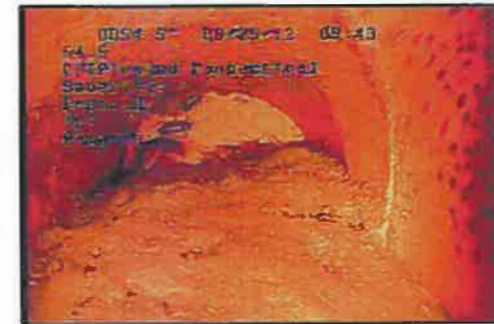
Date: 09/25/2012
 Distance: 54.5 Ft
 Obs: Plugged Connection

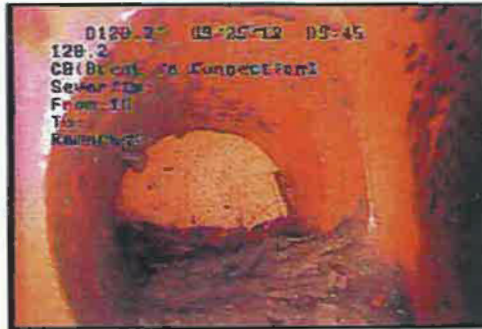
Date: 09/25/2012
 Distance: 128.2 Ft
 Obs: Break in Connection

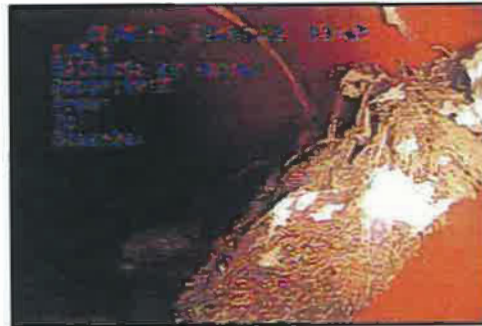
Date: 09/25/2012
 Distance: 164.3 Ft
 Obs: Roots at joint

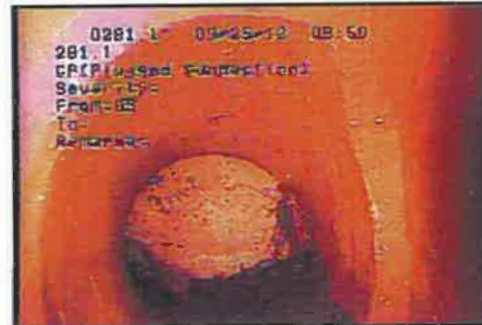
Date: 09/25/2012
 Distance: 281.1 Ft
 Obs: Plugged Connection

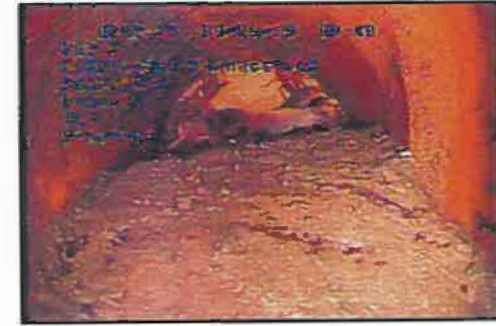
Date: 09/25/2012
 Distance: 207.4 Ft
 Obs: Plugged Connection

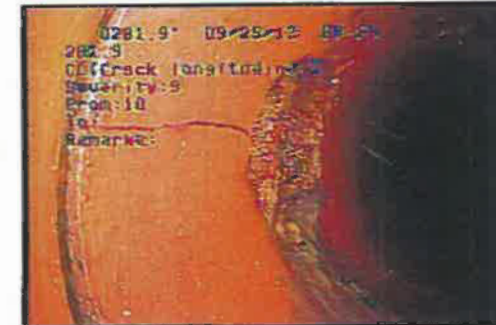
Date: 09/25/2012
 Distance: 281.9 Ft
 Obs: Crack longitudinal

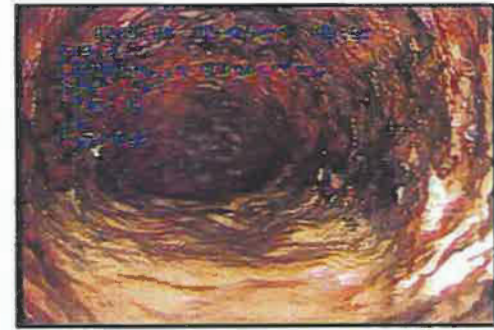
Date: 09/25/2012
Distance: 282.8 Ft
Obs: Break in Connection

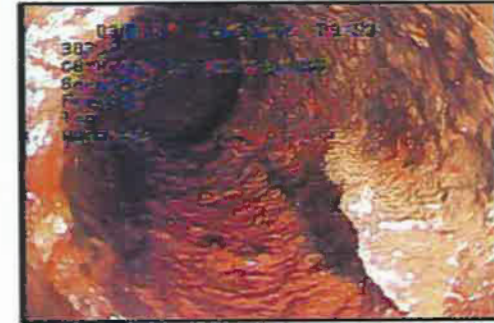
Date: 09/25/2012
Distance: 303.5 Ft
Obs: Break in Connection

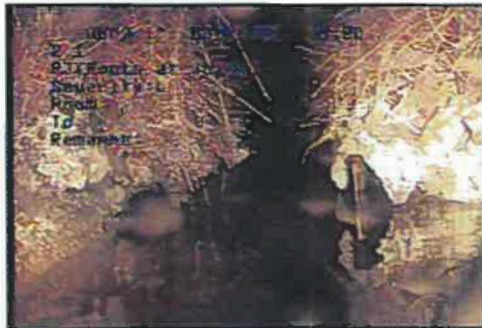
Date: 09/26/2012
Distance: 2.1 Ft
Obs: Roots at joint

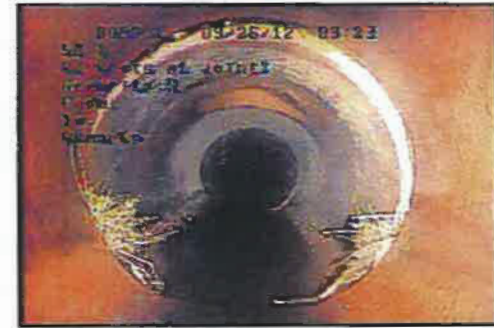
Date: 09/26/2012
Distance: 50.1 Ft
Obs: Roots at joint

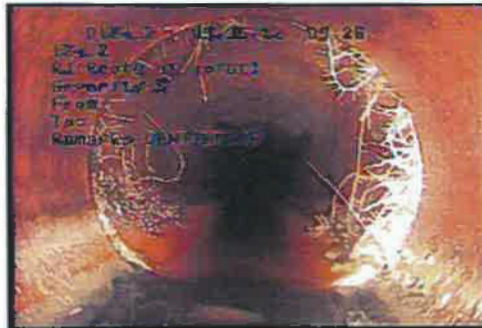
Date: 09/26/2012
 Distance: 124.2 Ft
 Obs: Roots at joint

Comments:
 CONTINUING

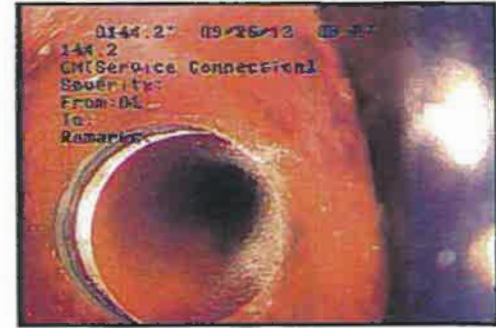
Date: 09/26/2012
 Distance: 144.2 Ft
 Obs: Service Connection

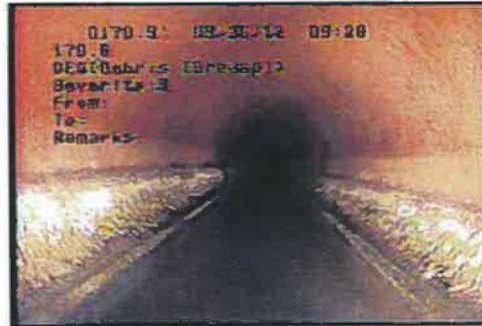
Date: 09/26/2012
 Distance: 170.8 Ft
 Obs: Debris (Grease)

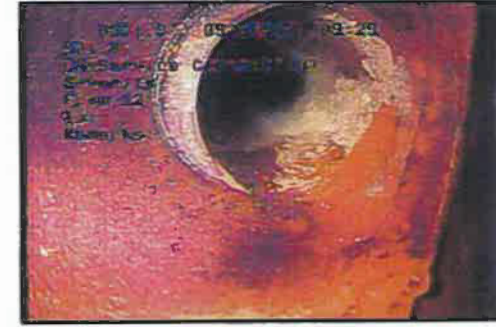
Date: 09/26/2012
 Distance: 231.3 Ft
 Obs: Service Connection

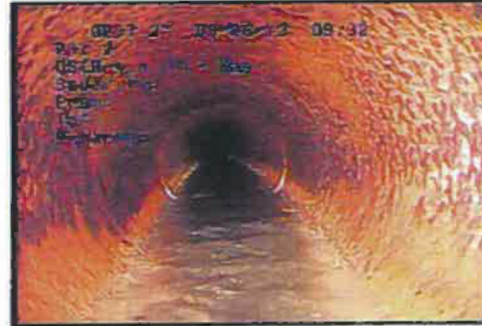
Date: 09/26/2012
 Distance: 297.2 Ft
 Obs: Begin Pipe Sag

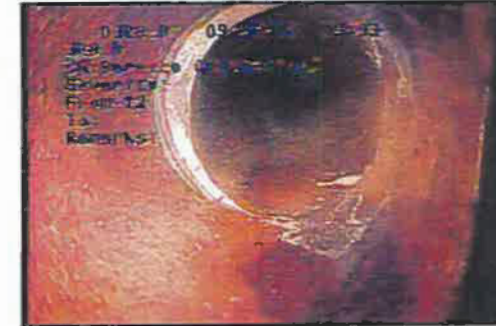
Date: 09/26/2012
 Distance: 328.9 Ft
 Obs: Service Connection

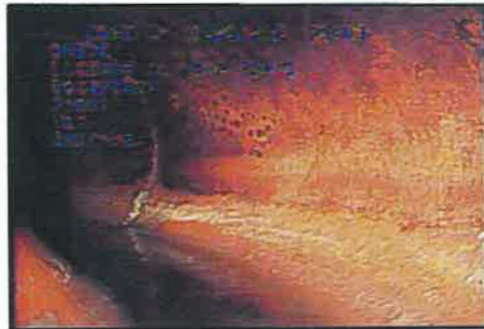
Obs: Bend in pipe left
